**APPENDIX B**

**SITE VISIT PHOTOGRAPHS**

**PARCEL 1**

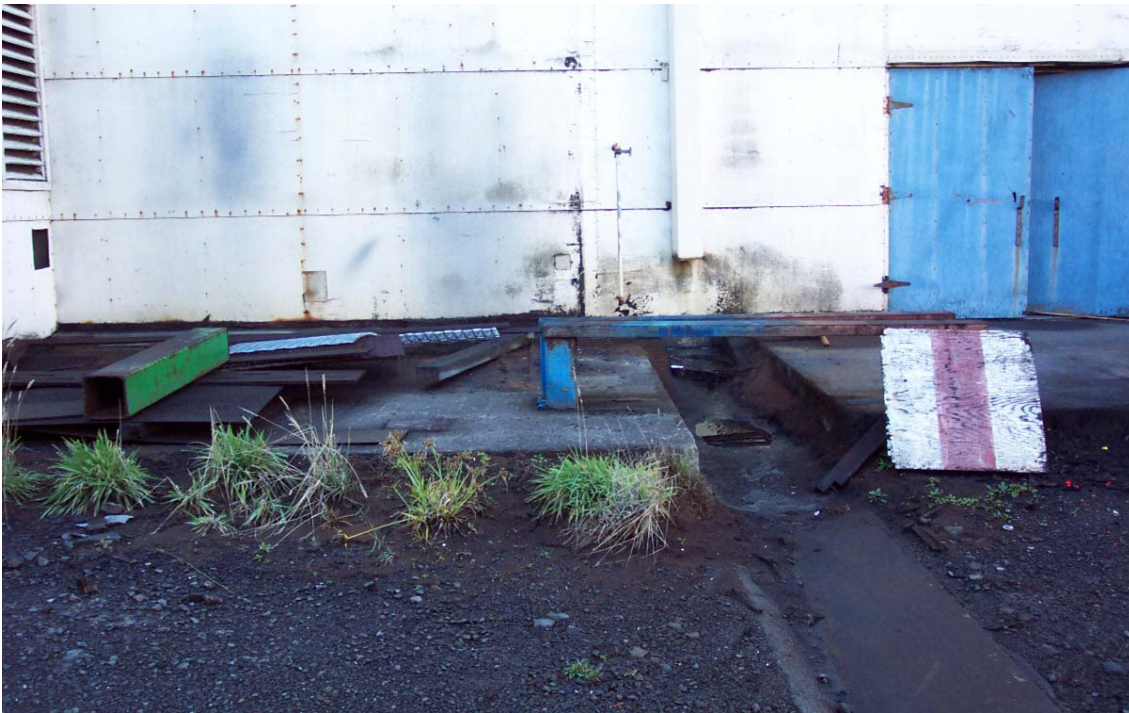
Photo 4. Stained concrete and soil outside the central area of Planer Mill No. 2.

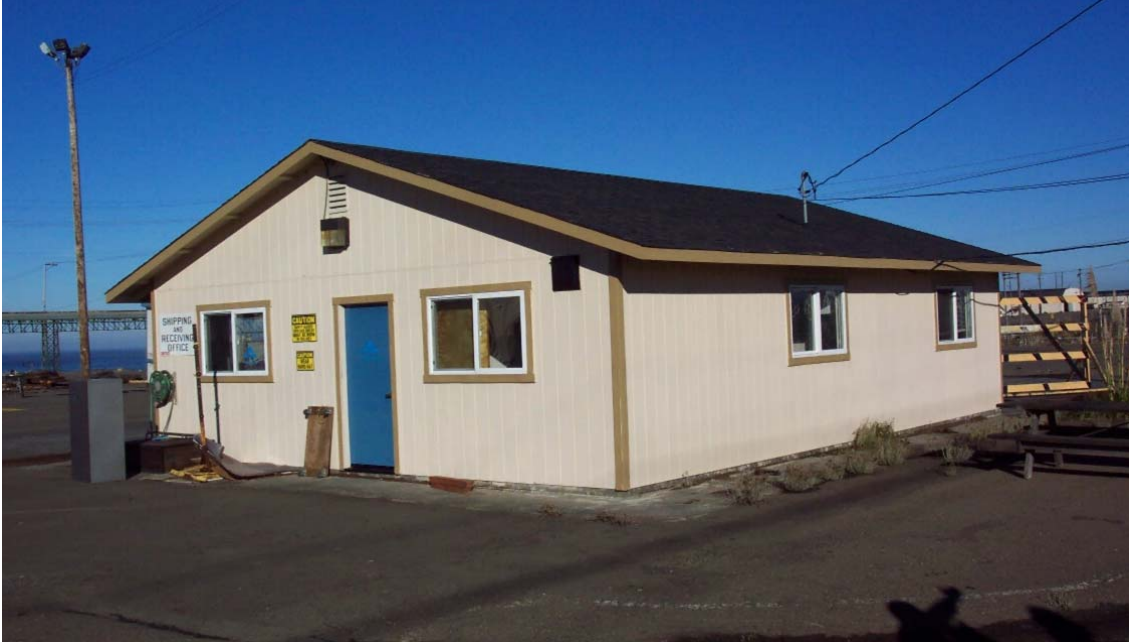
Photo 5. Shipping Office.

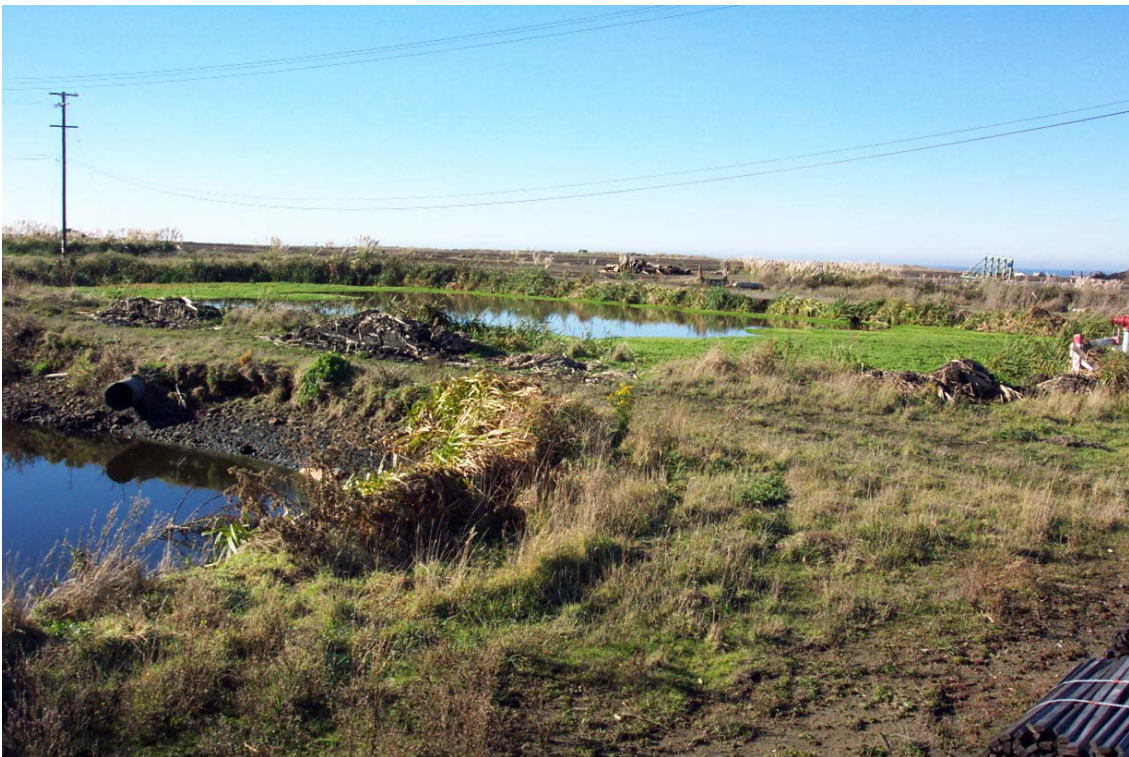
Photo 2. South Ponds on Parcel 7.

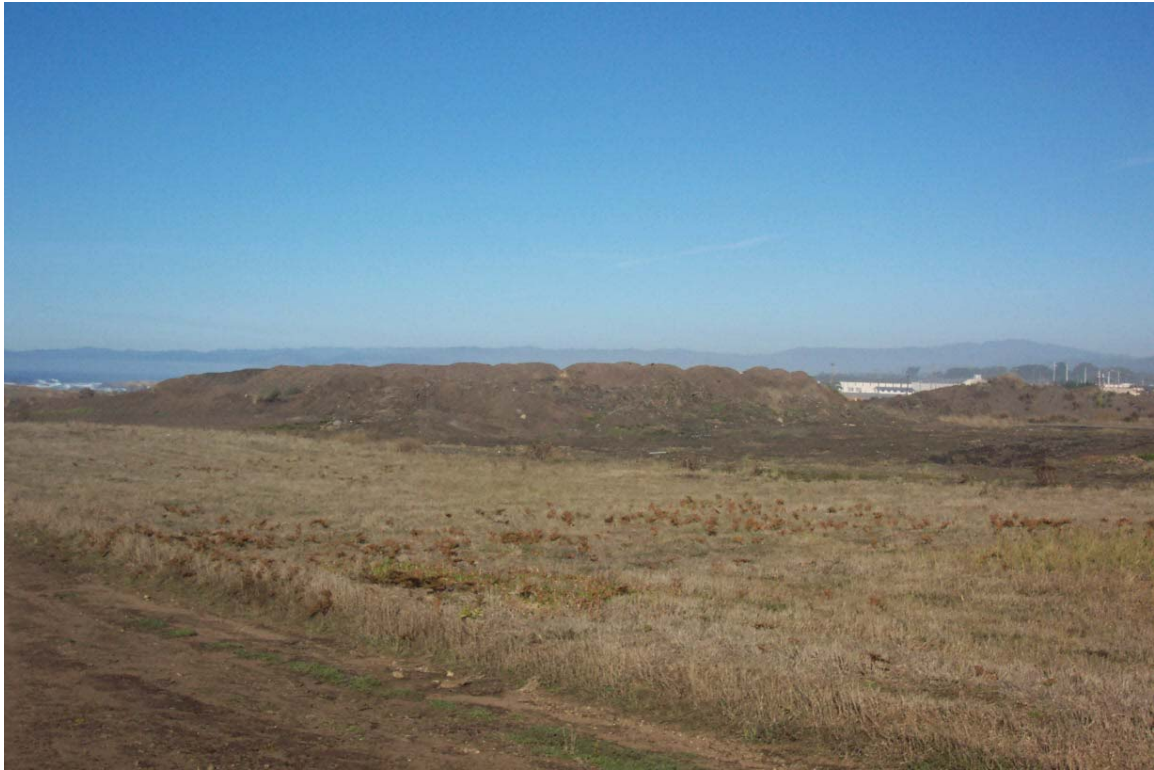
Photo 1. Clunker Piles.

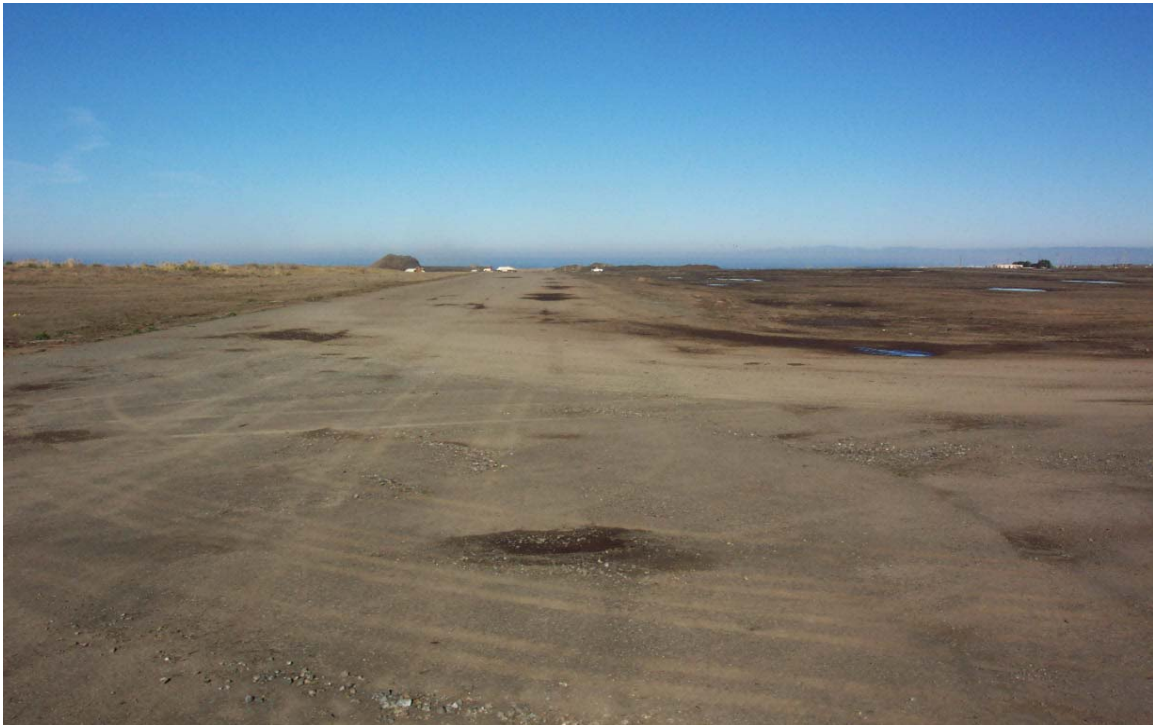
Photo 2. Airstrip.

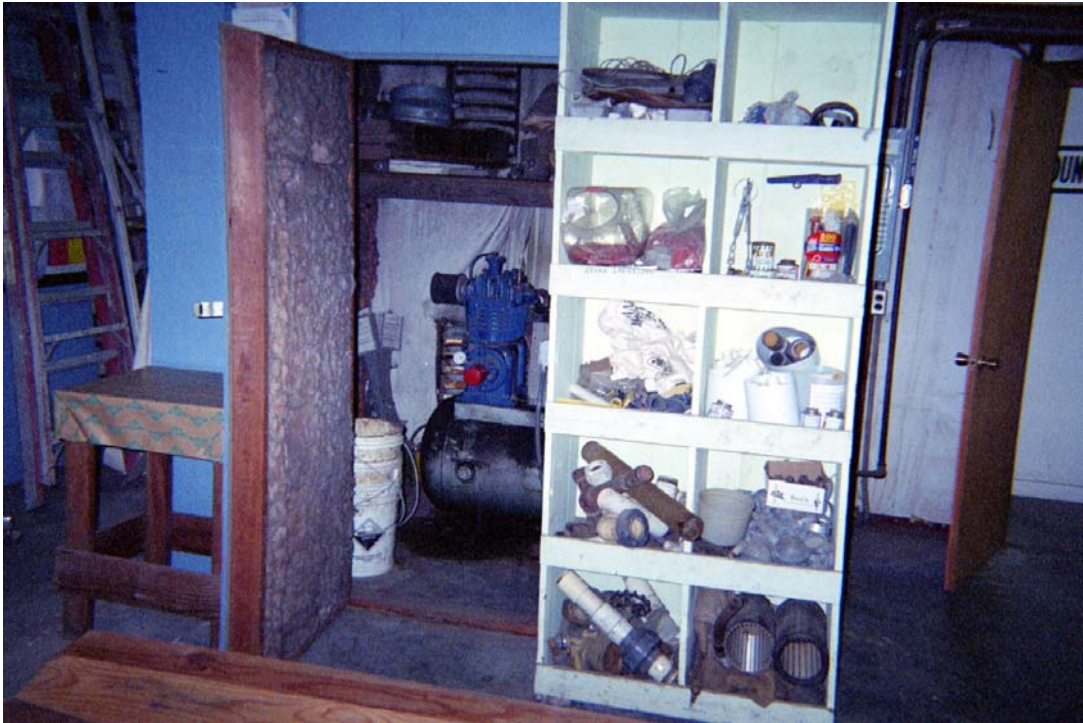
Photo 1. Air Compressor inside Main Packing Shed.

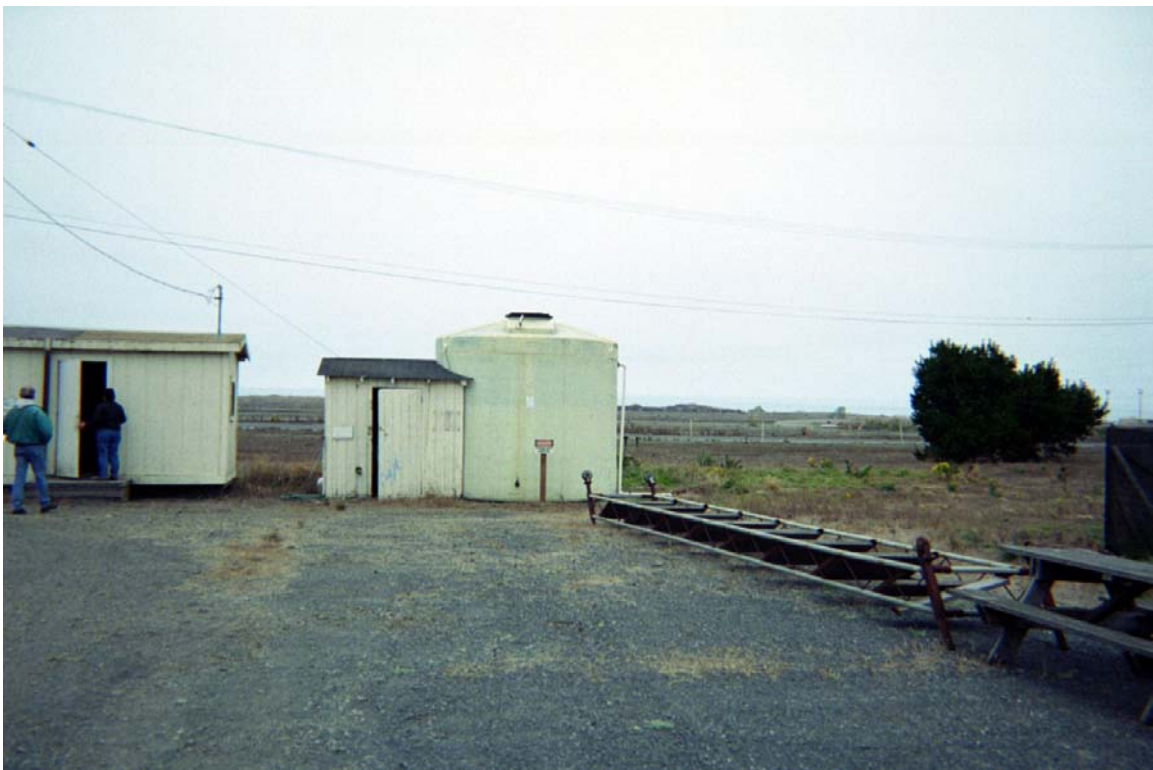
Photo 2. Holding Tank, pump house, and chemical storage shed.

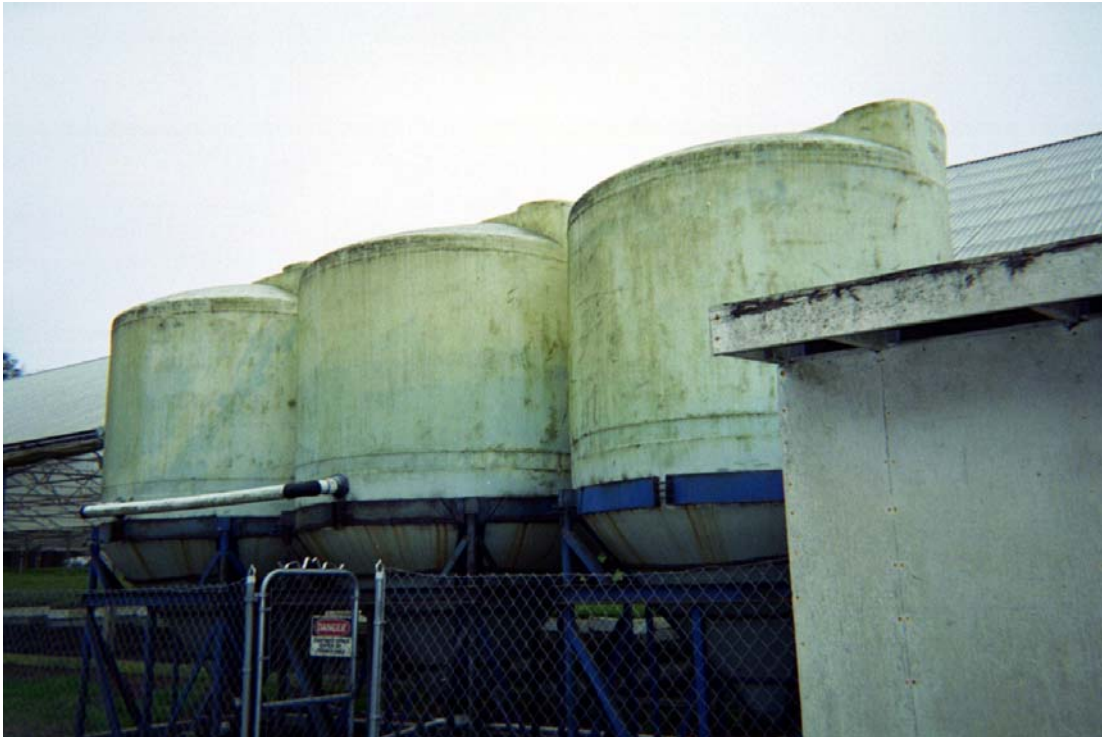
Photo 3. Water filtration and purification system tanks. Tanks have been removed.

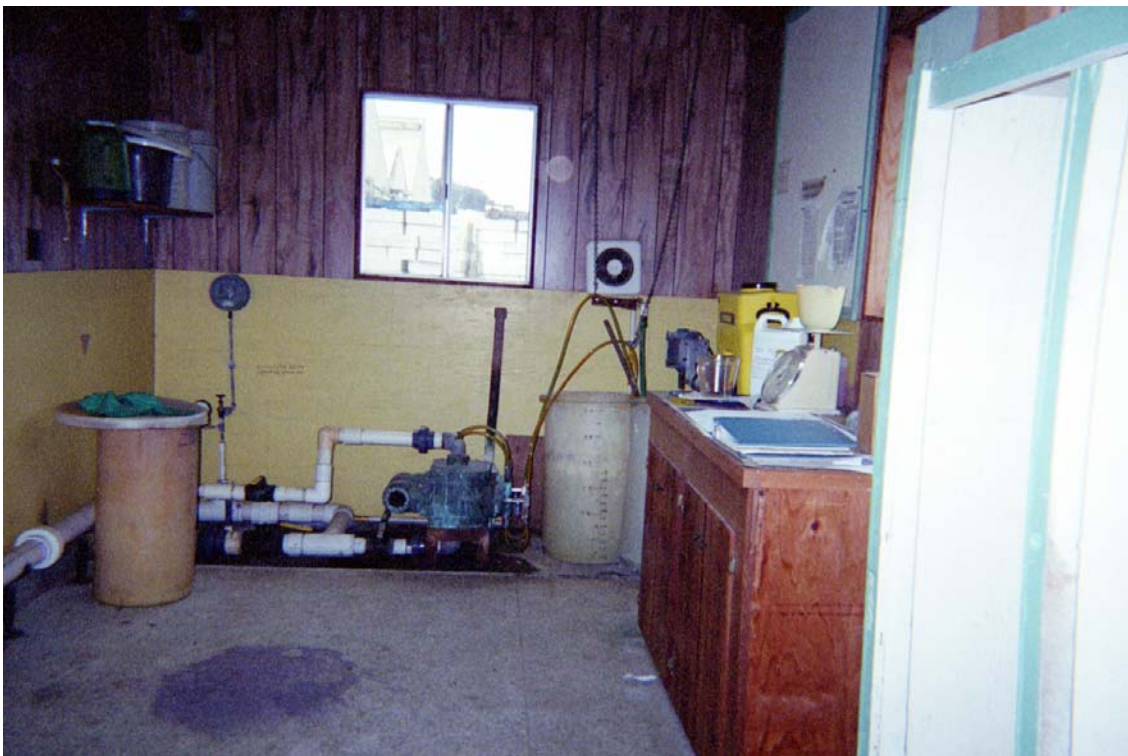
Photo 4. Chemical mixing shed.

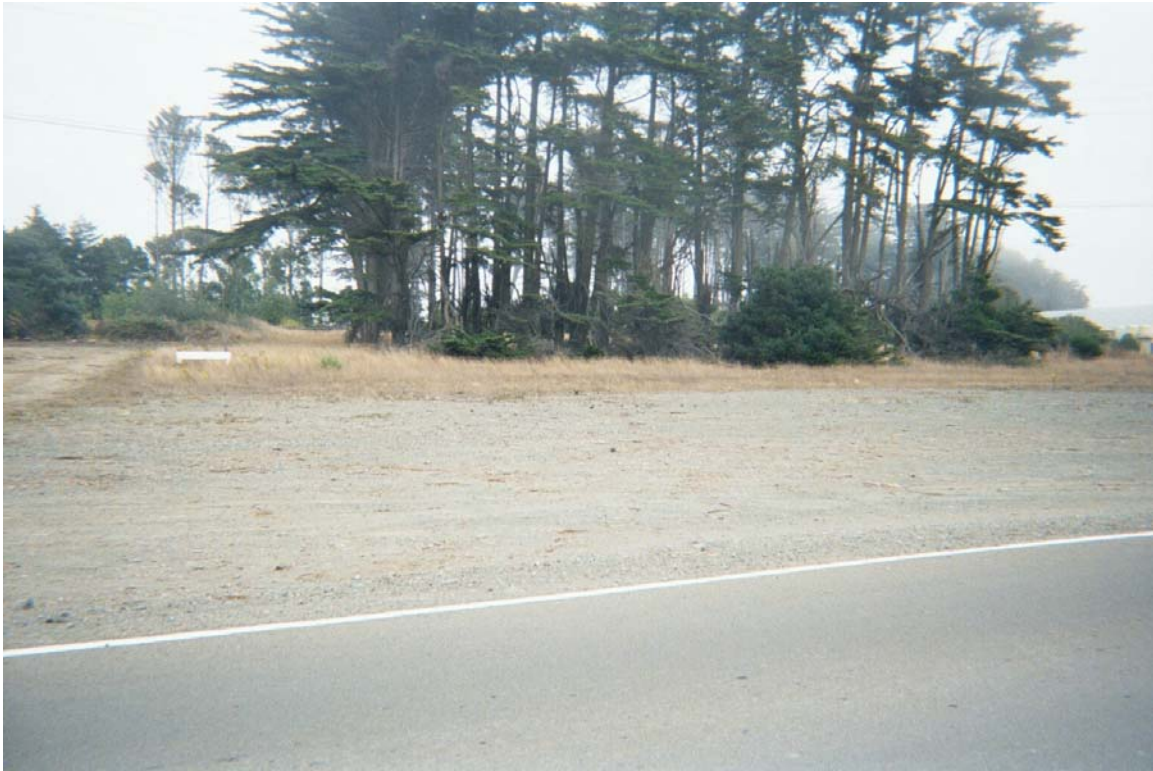
Photo 5. Scrap Metal Area.

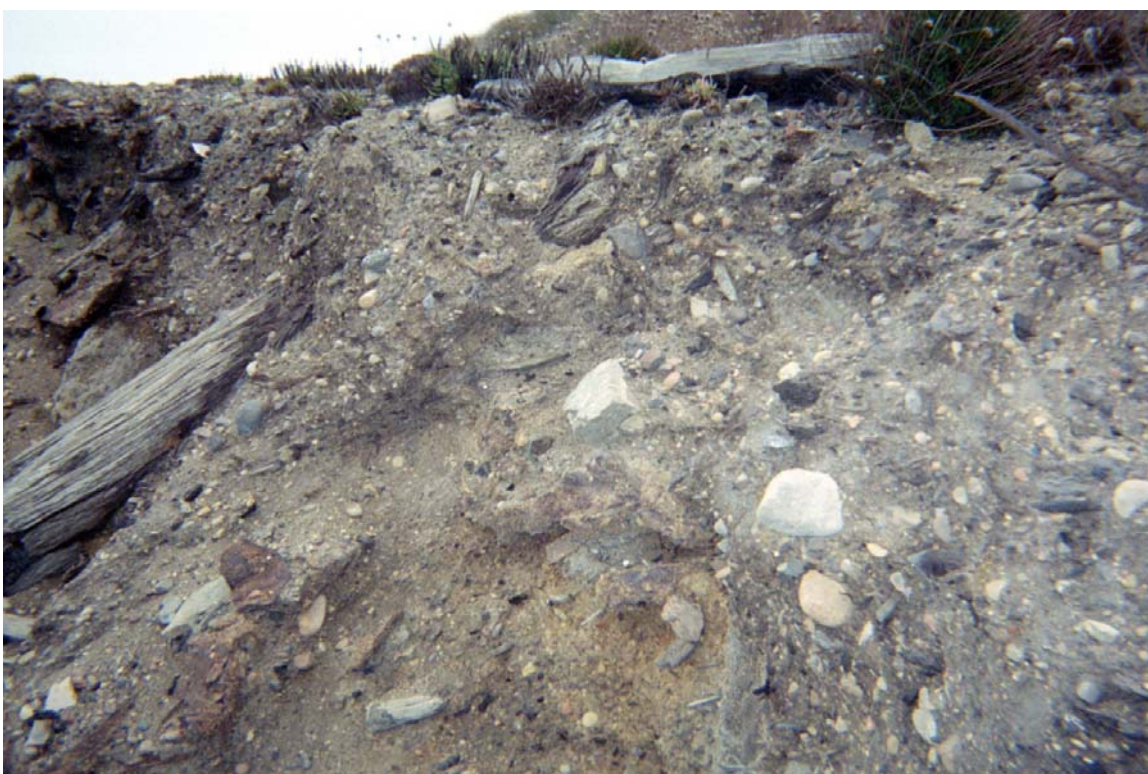
Photo 2. Clinkers and suspect fill material along coastline of Parcel 10.

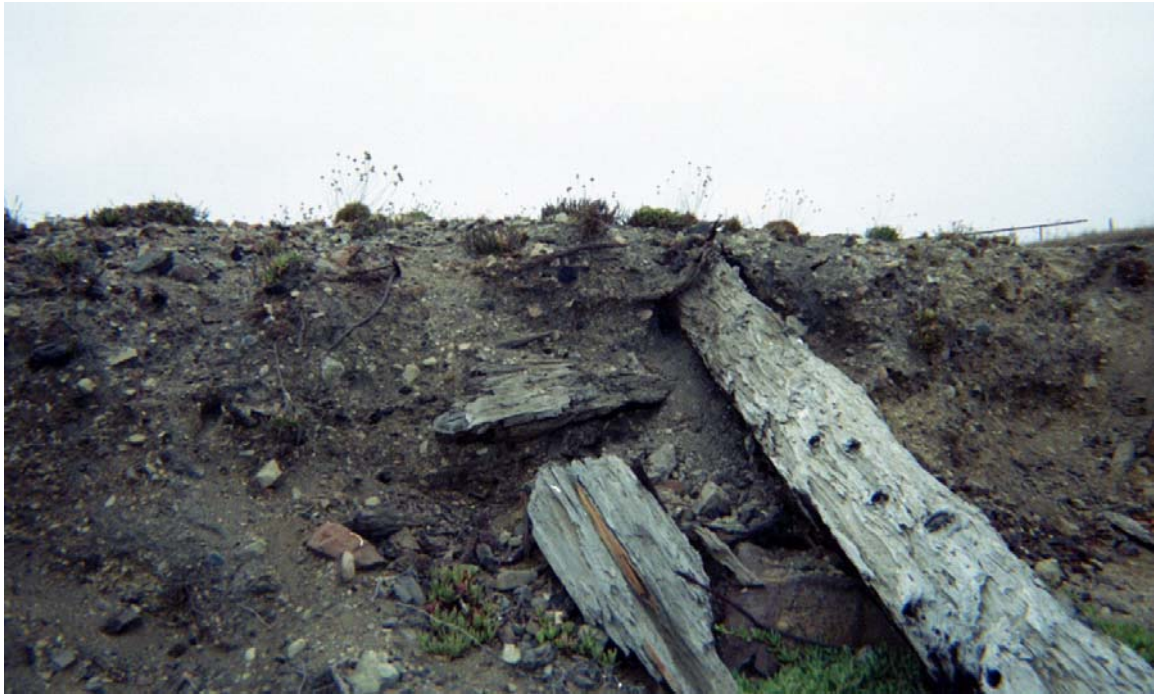
Photo 3. Wood debris and clinkers emanating from soil along coastline of Parcel 10.

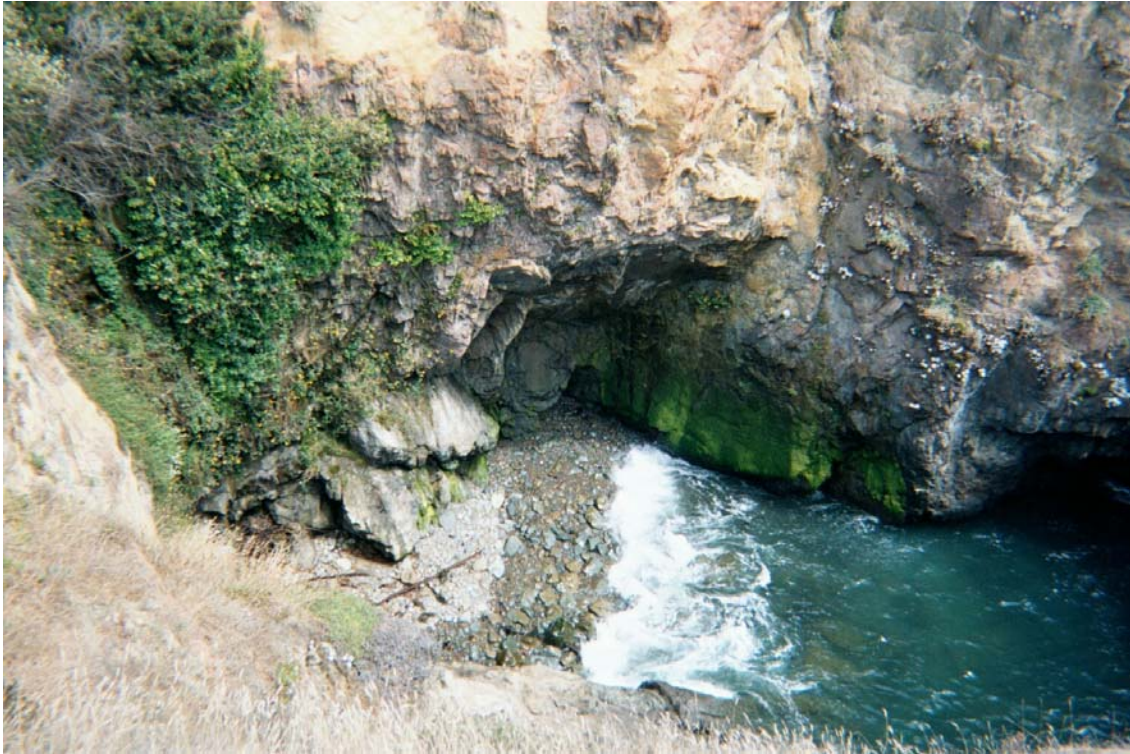
Photo 5. Blowhole on Parcel 10 – Scrap iron present in lower left corner.

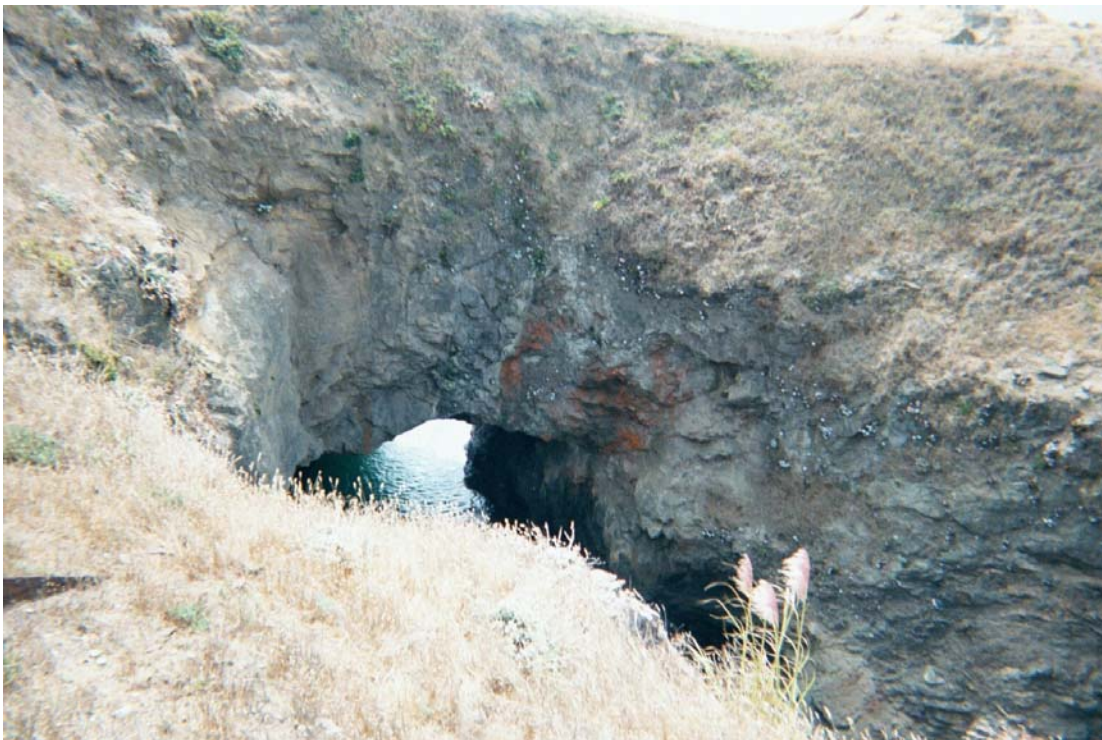
Photo 6. Discoloration along western wall of Blowhole.

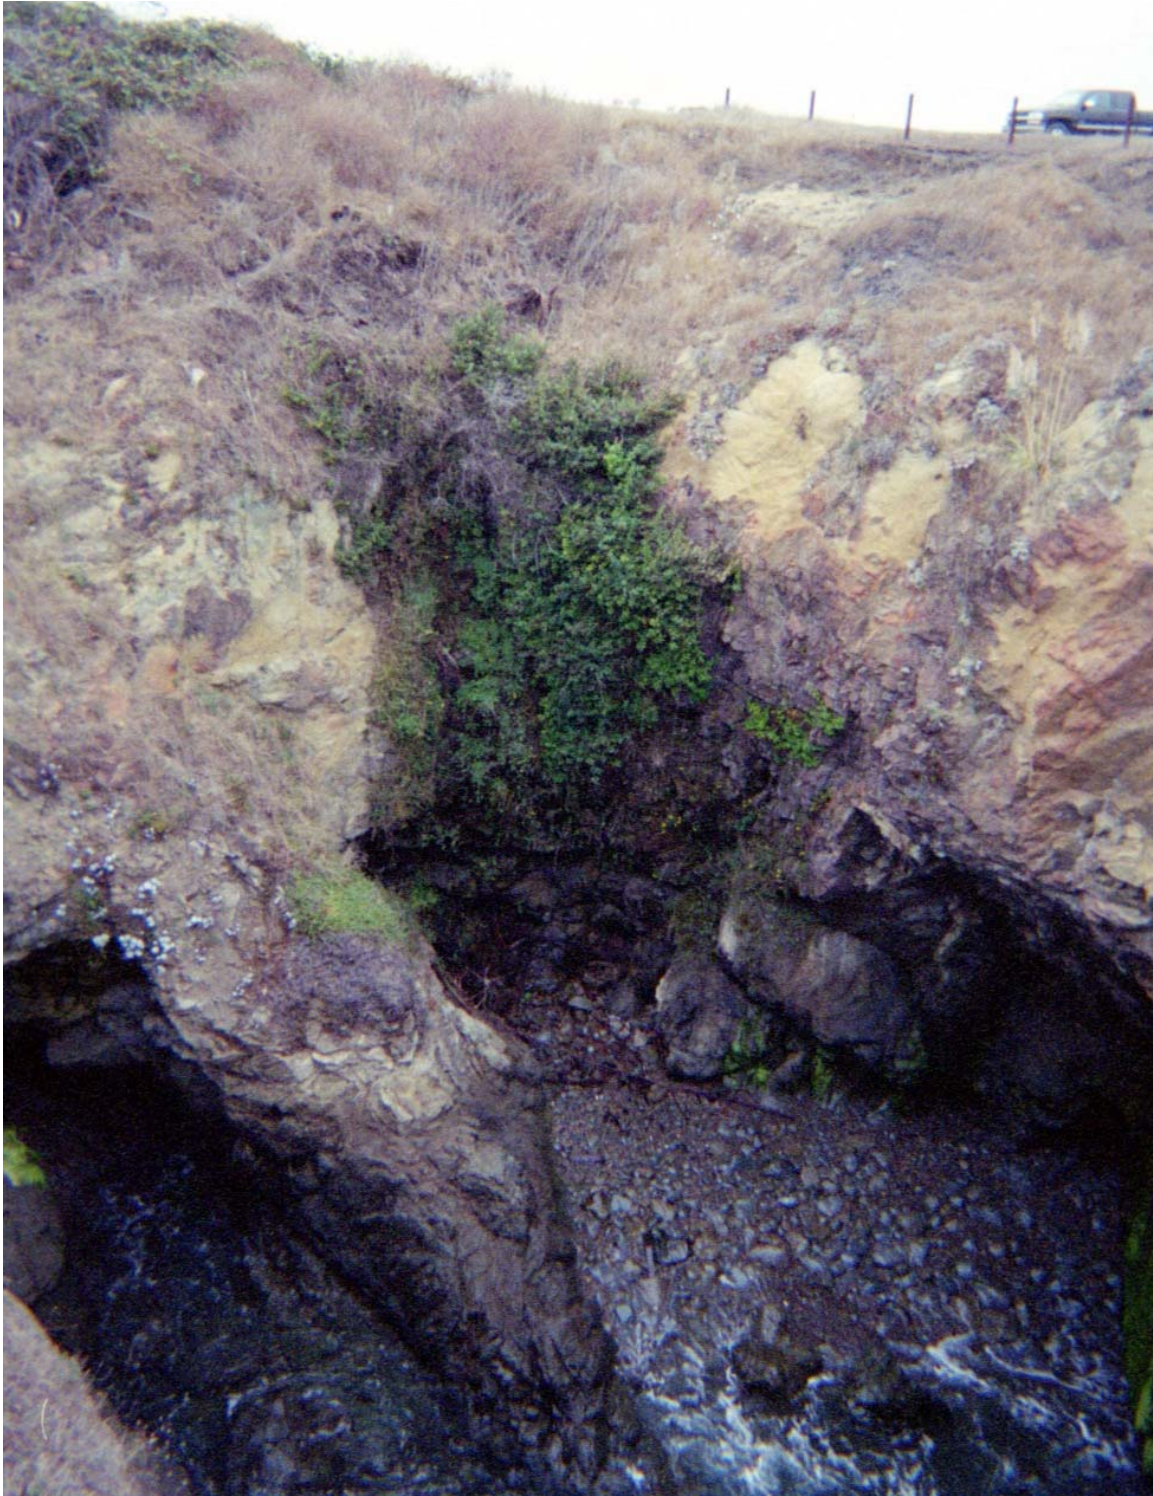
Photo 7. Western wall of Blowhole – Slight discoloration of walls and suspect debris fill material present.
